FEASIBILITY STUDY – BA 355

CITY OF EDINA

GOLF TERRACE NEIGHBORHOOD ROADWAY IMPROVEMENTS
JANUARY 4, 2011
Revised March 15, 2011

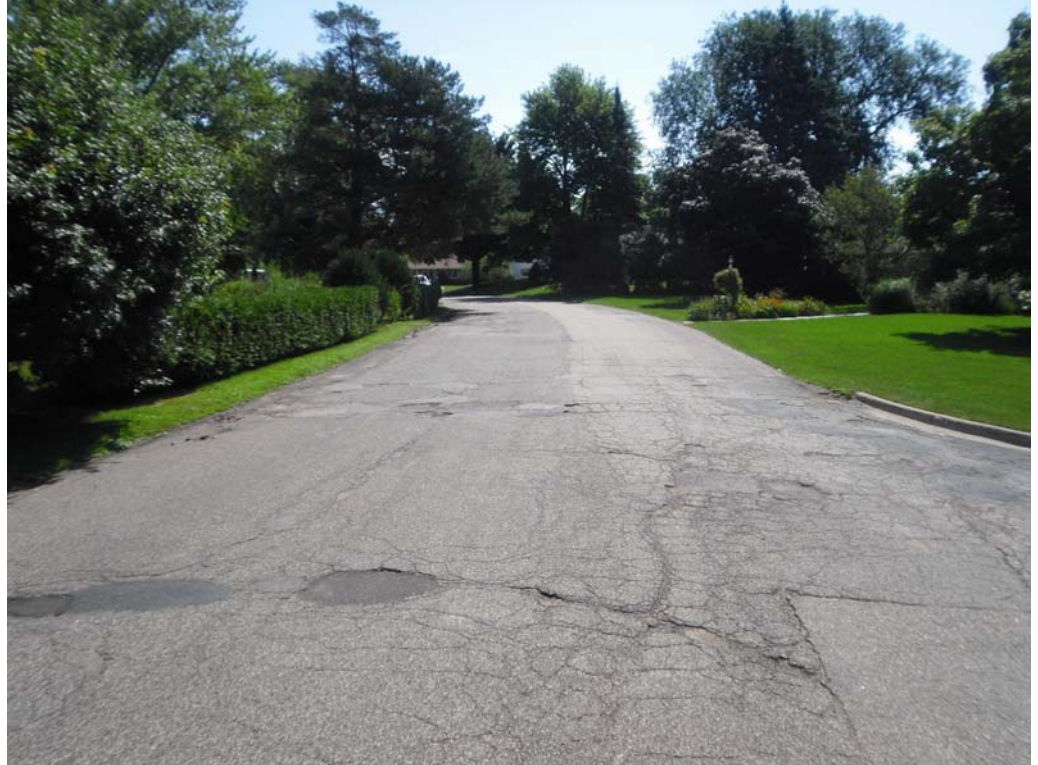
Photo 1. Existing Pavement Condition

Roadways in this neighborhood were originally constructed in the early 1940’s and early 1950’s. The majority of the north half of the neighborhood currently does not have curb and gutter and the roadway widths vary from 26 to 28 feet wide. The south half of the neighborhood has curb and gutter with a width of approximately 30-feet wide. The pavement condition varies throughout the neighborhood and is in relatively poor condition (Photos 1 & 2).

The average Pavement Condition Index (PCI) for the City of Edina is 57 and the average PCI for Golf Terrace is 7. Examples of the raveling and alligator cracking can be seen in photos 1 & 2. The City of Edina recently hired a consultant to evaluate all bituminous roadways within the City. The streets were graded based on a number of conditions such as sagging, alligator cracking, raveling and potholes. Streets are rated on a scale from 0 to 100; with 0 being extremely poor and 100 representing a brand new road surface. It is the City’s practice to complete a total reconstruction of the streets when the PCI is less than 45, a Mill and Overlay project when the PCI is between 45 and 65, and Seal Coats for PCI greater than 65 and less than 95.

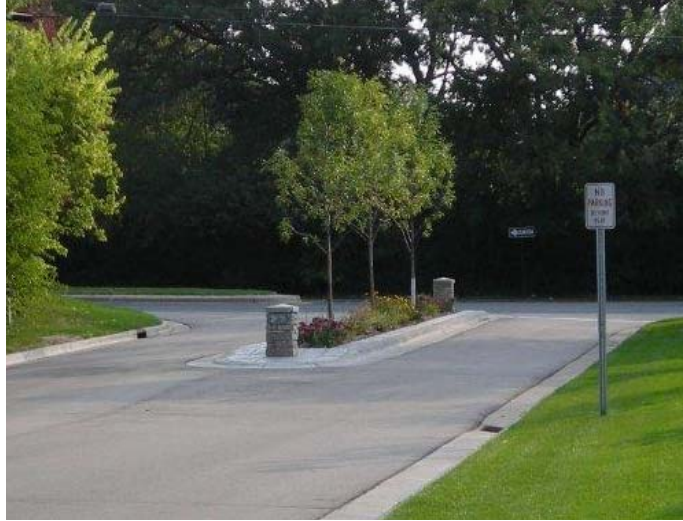
Figure 2. Landscape Island

Residents requested that staff look into the feasibility of installing traffic calming measures with the project. Based on that discussion staff is recommending installing landscape islands at the intersections of the Wilson Road /Wind Road and Wilson Road/Lakeview Drive. These islands would be similar to the islands installed at West 70th Street and Cornelia Drive. Sidewalks will be installed at these locations to separate pedestrian and vehicles through the island areas (Figure 2).

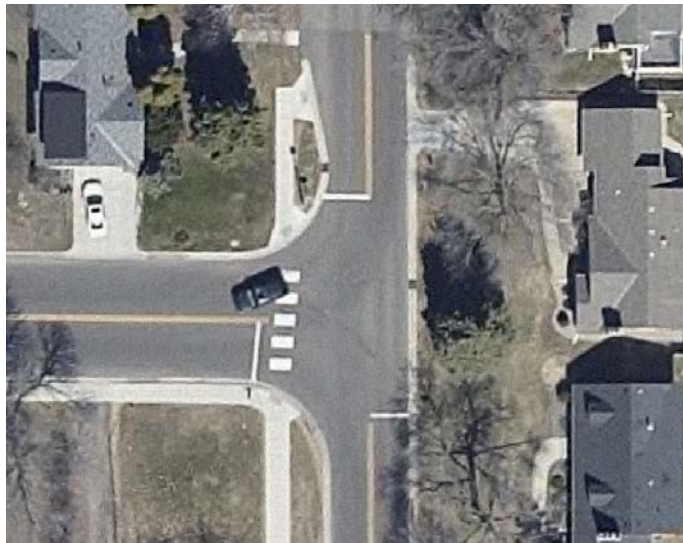
Figure 3. Aerial Photo of Bump Out

In addition, bump-outs will be installed at the intersections of Southview Lane and Sherwood Avenue, Southview Lane and Dalrymple Road, and Southview Lane and St. Andrews Avenue. These bump-outs will be similar to the bump-out on the north side of Southview Lane and Concord Avenue (Figure 3).

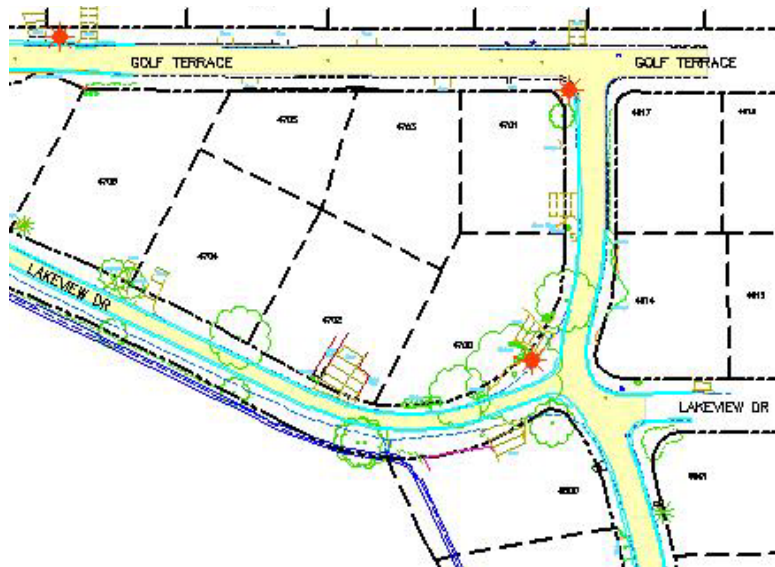
Figure 4. Lakeview Drive Reconfiguration

Staff is proposing to reconfigure the intersection of the Lakeview Drives at the northeast corner of Harvey Lake (Figure 4). This revision should help to slow traffic at this intersection and redirect traffic off of Lakeview Drive north of Lake Harvey.

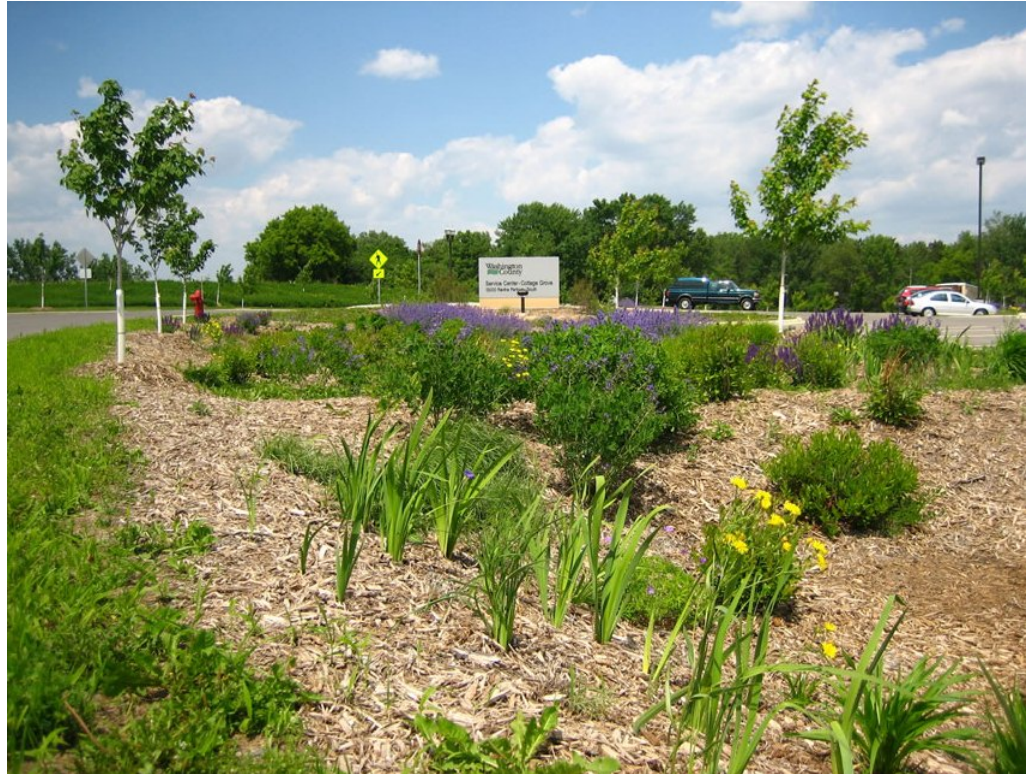
Photo 3. Filtration Swale

The filtration swale would be graded to capture and treat the stormwater runoff thru horizontal filtration. The swale would be planted with native plantings and the aesthetics would be similar to a rain garden (Photo 3). The construction costs for the filtration swale are approximately \$10,000 to \$15,000 and would be funded through the Storm Sewer Utility fund. It is anticipated that the combination of the reduction in road width and the filtration swale would remove approximately 2 lbs. of phosphorus loading to Harvey Lake.

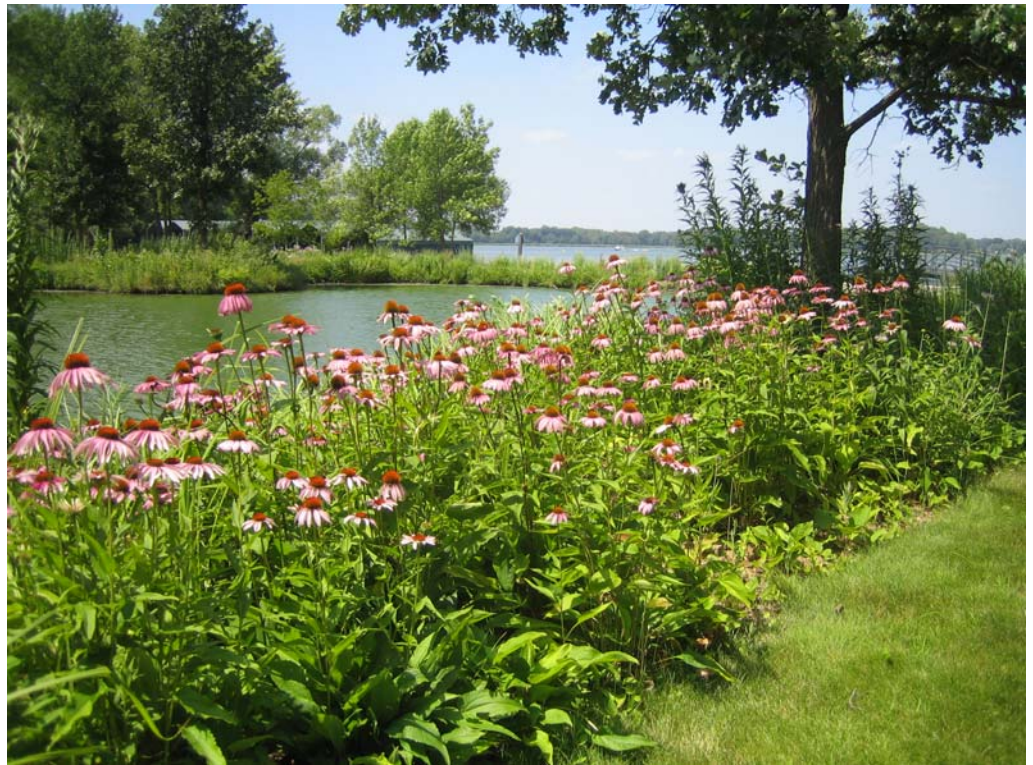
Photo 4. Shoreline Restoration/Buffer

Shoreline restoration/buffers (Photo 4) should be implemented in conjunction with the filtration swales. From aerial photos, the lawns of most of the properties surrounding the lake are mowed to the waters' edge. All of these properties are encouraged to install shoreline stabilization and a buffer strip along the shoreline. According to MCWD Wetland Protection Rule, the minimum buffer strip would be 20'. This buffer strip would filter approximately 4 acres of runoff from private property before it drains directly into Harvey Lake. The cost of the lake shore restoration and buffer zone would be the responsibility of the private homeowners.
